SUBJECT: **SPECIAL POLICY ADJUSTMENT FOR 1988 – EARLY 1990 TRUCK &
4RUNNER WITH 3VZ-E V6 ENGINES
AND
SPECIAL SERVICE CAMPAIGN (V06) FOR 1990 – EARLY 1995 TRUCK,
4RUNNER & T100 WITH 3VZ-E V6 ENGINES**

3VZ-E Head Gasket Special Policy Adjustment

3VZ-E Head Gasket Special Service Campaign (V06)

3VZ-E Cylinder Head/Block Inspection

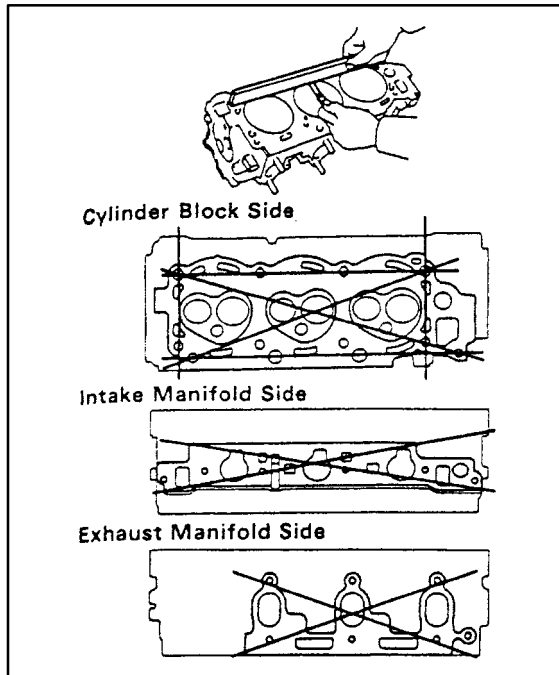
2. INSPECT CYLINDER HEAD FOR FLATNESS.

- (a). Using a precision straight edge and feeler gauge, measure the surfaces contacting the cylinder block and the manifolds for warpage.

CYLINDER HEAD MEASUREMENT		
Less than 0.10 mm (0.0039 in)	More than 0.10 mm (0.0039 in) but less than 0.25 mm (0.010 in)	More than 0.25 mm (0.010 in)
Cylinder head may be reused without machining	*Cylinder head may be machined to a maximum of 0.25 mm (0.010 in)	Cylinder head must be replaced

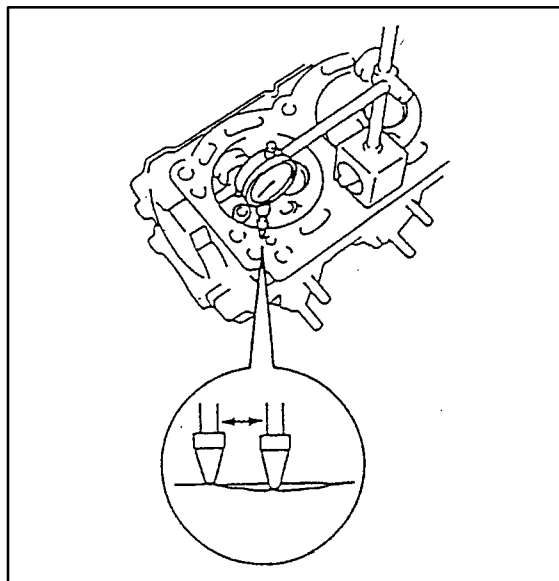
3. MEASURE CYLINDER BLOCK CONTACT SURFACES FOR DEPTH OF EROSION.

- (a). Using a dial indicator, measure the depth of erosion of the surfaces contacting the cylinder head gasket.

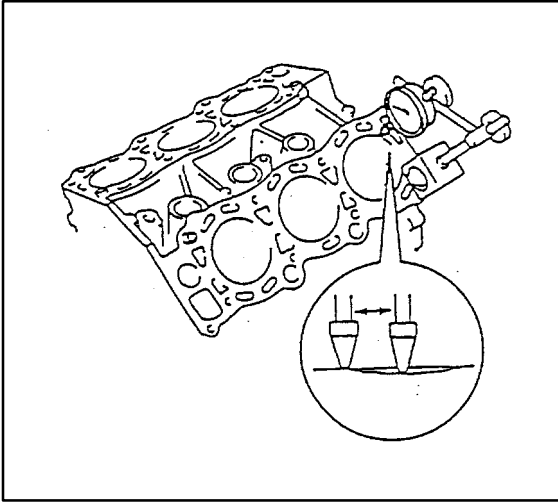
3. MEASURE TOP SURFACE OF CYLINDER BLOCK FOR EROSION.

BLOCK MEASUREMENT		
Less than 0.05 mm (0.002 in)	More than 0.05 mm (0.002 in) but less than 0.25 mm (0.010 in)	More than 0.25 mm (0.010 in)
Block may be reused without machining	*Block may be machined to a maximum of 0.25 mm (0.010 in)	Replace short block assembly

***NOTE: WHEN MACHINING CYLINDER HEAD AND BLOCK THE COMBINED AMOUNT OF MATERIAL REMOVED MUST NOT EXCEED 0.25 mm (0.010 in).**

- (a). Using a dial indicator, measure the depth of erosion of the surfaces contacting the cylinder head gasket.

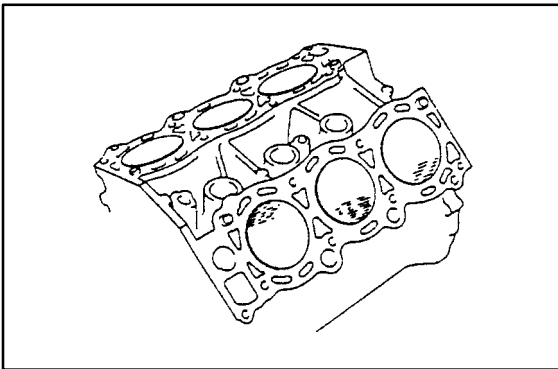
1. INSPECT CYLINDERS FOR VERTICAL SCRATCHES

- (a). Visually check the cylinders for vertical scratches. If deep scratches are present, replace the short block assembly.
