SUBJECT: **SPECIAL POLICY ADJUSTMENT FOR 1988 – EARLY 1990 TRUCK &
4RUNNER WITH 3VZ-E V6 ENGINES
AND
SPECIAL SERVICE CAMPAIGN (V06) FOR 1990 – EARLY 1995 TRUCK,
4RUNNER & T100 WITH 3VZ-E V6 ENGINES**

3VZ-E Head Gasket Special Policy Adjustment

3VZ-E Head Gasket Special Service Campaign (V06)

3VZ-E Cylinder Head/Block Inspection

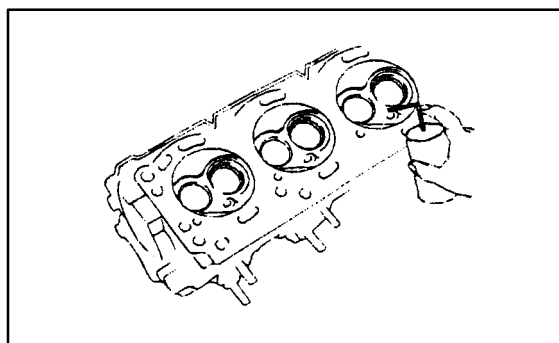
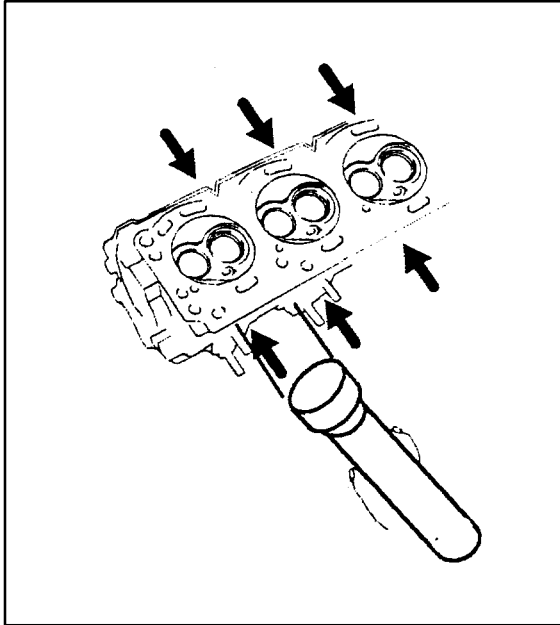
- (a). With the cylinder head inverted and the spark plugs installed, fill the combustion chambers with solvent to determine if any of the valves or valve seats have been damaged by the entry of coolant into the cylinder.

- (b) Examine the intake and exhaust ports for signs of the solvent leaking past the valve seats, paying particular attention to cylinders number one and number six. If any solvent leakage is detected those valves must be removed for further inspection and repair as necessary.

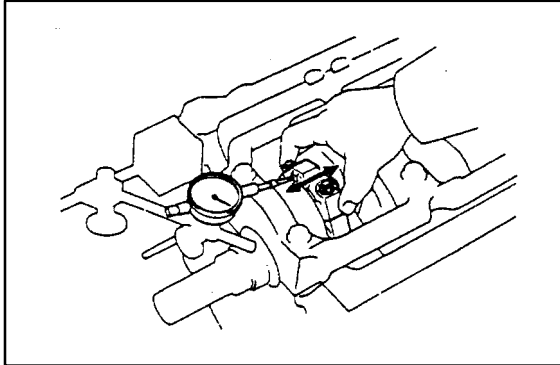
1. CHECK CONNECTING ROD THRUST CLEARANCE

- (a). Using a dial indicator, measure the thrust clearance while moving the connecting rod back and forth.

0.38 mm (0.0150 in)

If the thrust clearance is greater than maximum, replace the short block assembly.

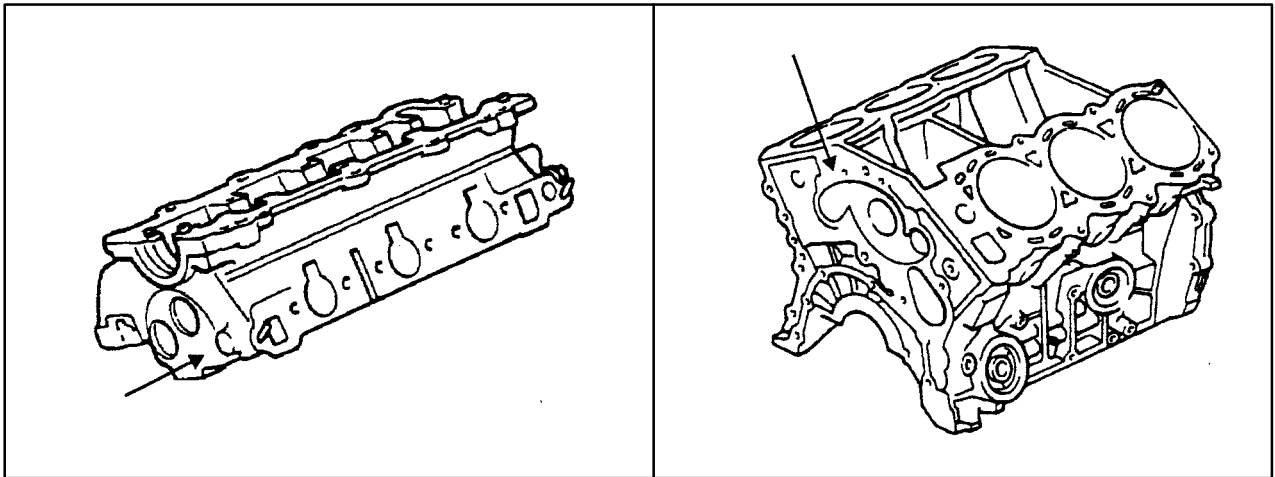
If the crankshaft connecting rods and pistons are serviceable and the cylinder block is not warped or eroded beyond specification, the block cylinder head surface may be machined.

In order to perform this machining operation correctly, equipment that will produce a smooth, flat, and scratch free surface must be utilized. In addition, this machine must be capable of accurately measuring the amount of material that is being removed. Following this machining operation the amount of material that has been removed must be indicated on the cylinder head and/or block by stamping the end surface as indicated.

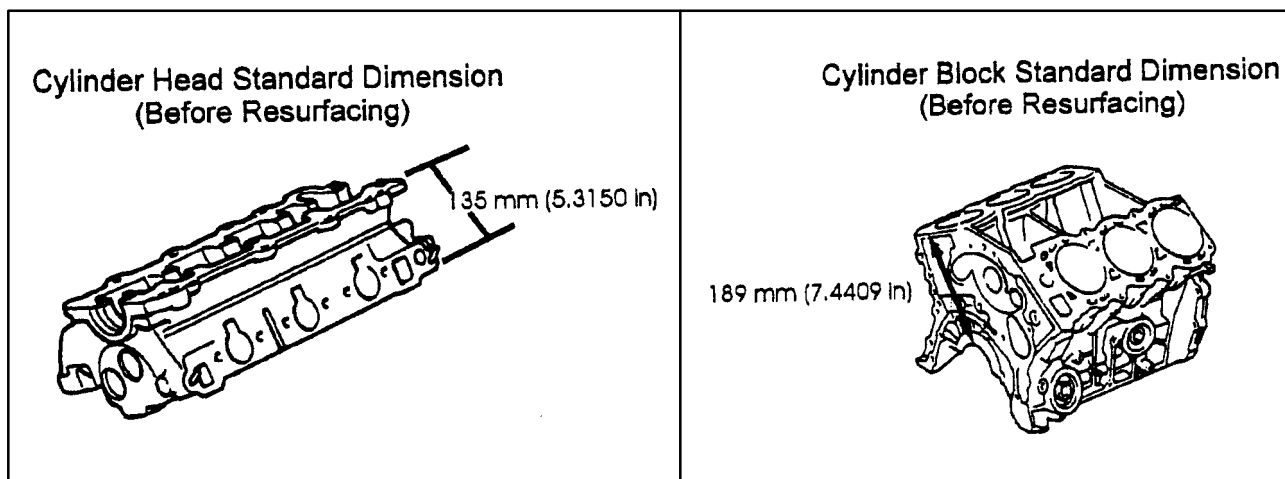
If you are uncertain as to whether or not a cylinder head or block has previously been machined, confirm the measurement of the head and/or block using the dimensions provided below.
